Rawlins County USD 105 Facility Assessment

Elementary School Assessment

Junior/Senior High School Assessment

Agriculture and Maintenance Shop Assessment

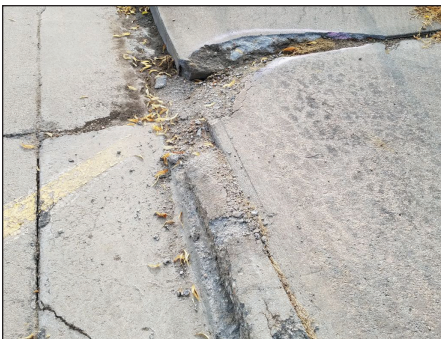
DAMAGED SIDEWALK

4. High-voltage equipment, gas meter, and air conditioning units all exposed in playground area.
5. Sidewalks have cracks in areas.
6. North sidewalks have multiple cracks and areas of erosion.

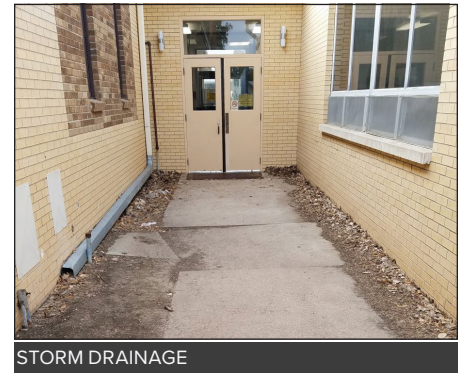
13. Storm water drainage concern at building courtyard running into air handling unit.
14. Some settlement of concrete causing low spots near building foundation.

STORM DRAINAGE

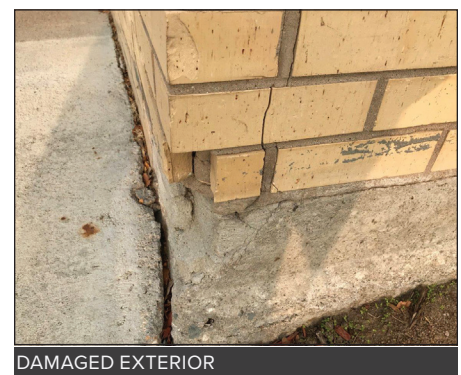
DAMAGED EXTERIOR

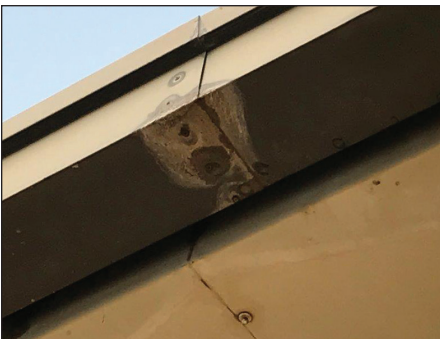
LEAKING GUTTER

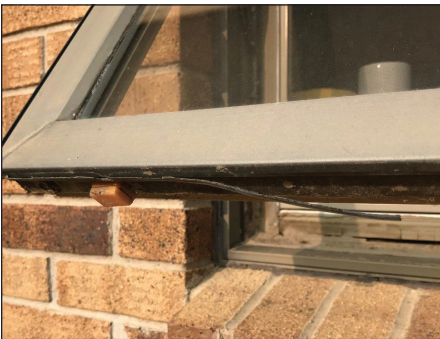
WINDOW GASKETS

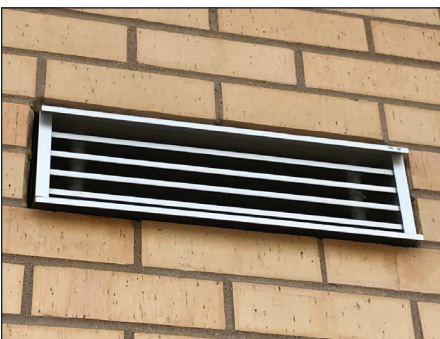
MISSING SEALANT

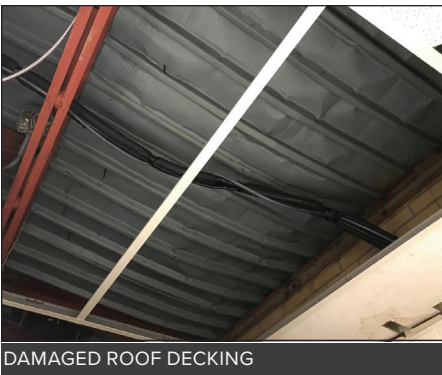
DAMAGED ROOF DECKING

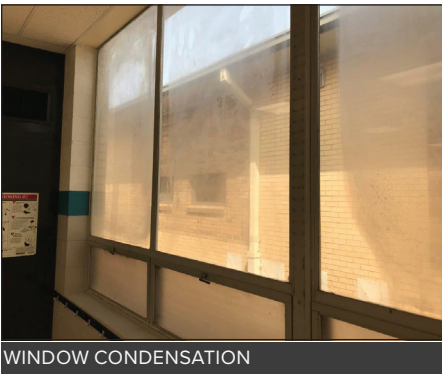
WINDOW CONDENSATION

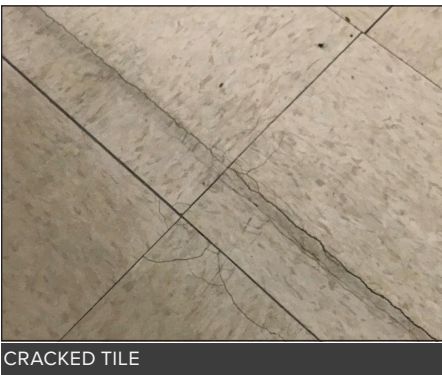
CRACKED TILE

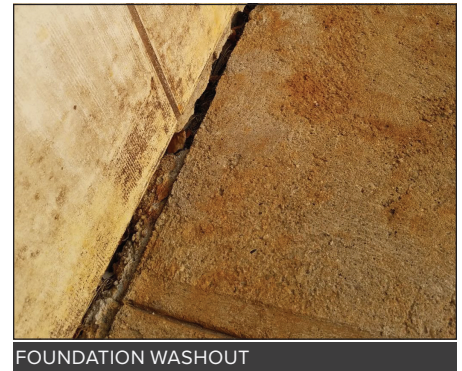
FOUNDATION WASHOUT

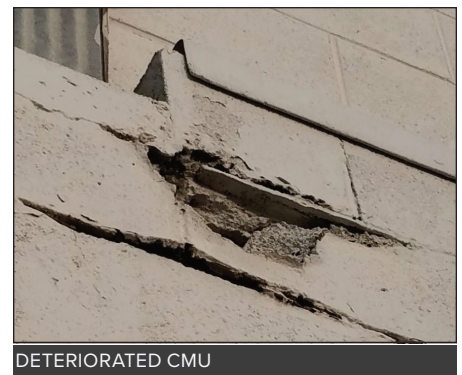
DETERIORATED CMU

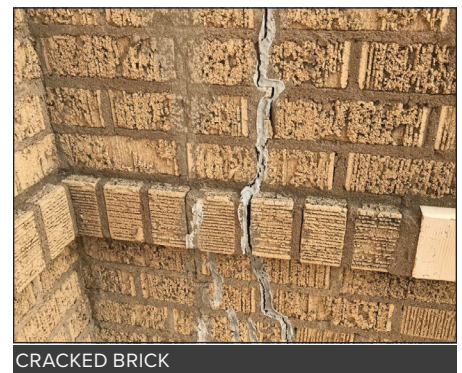
CRACKED BRICK

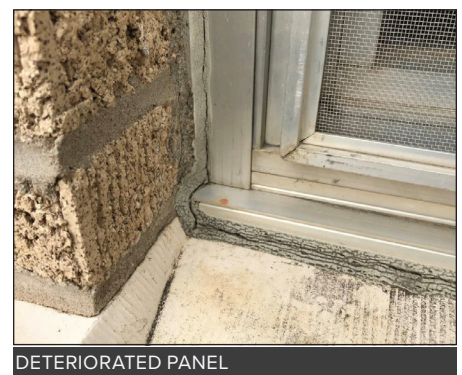
DETERIORATED PANEL

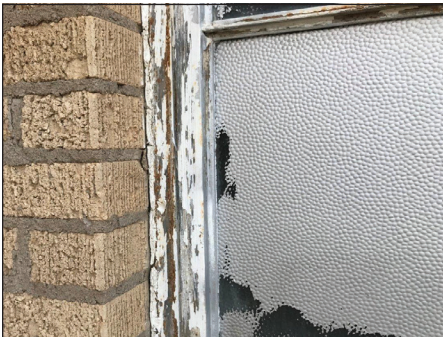
DETERIORATED WINDOW

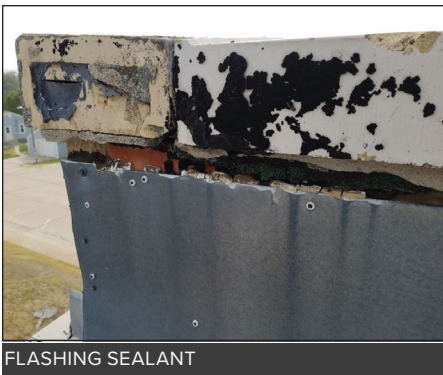
FLASHING SEALANT

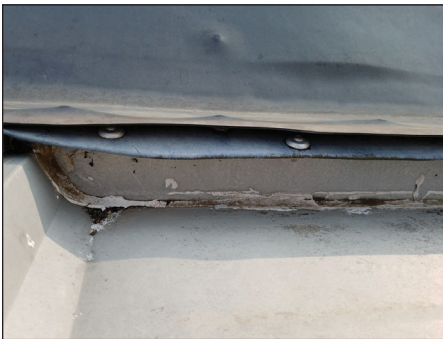
LOOSE ROOF MEMBRANE

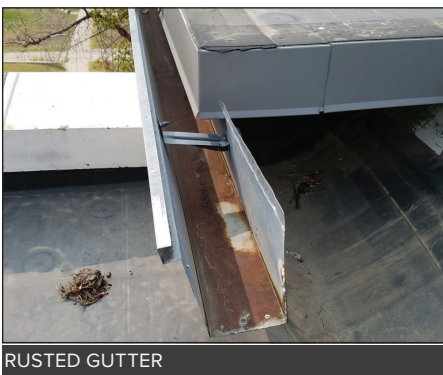
RUSTED GUTTER

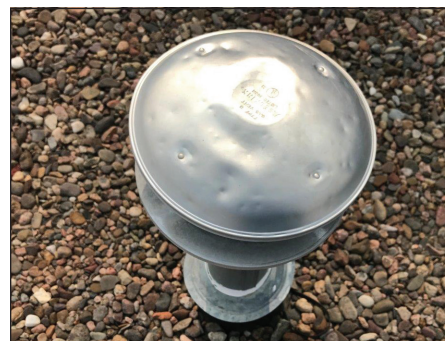
HAIL DAMAGE

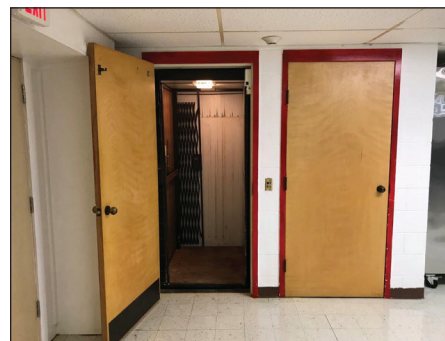
NON-COMPLIANT ELEVATOR

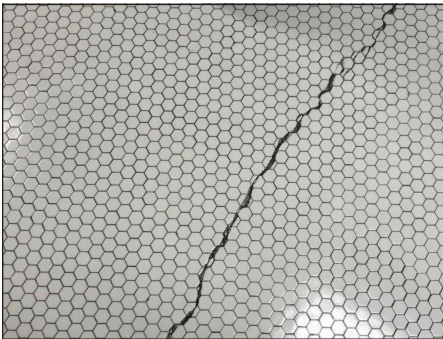
CRACKED FLOORING

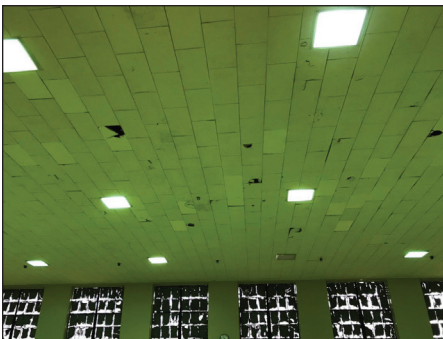
DAMAGED CEILING TILES

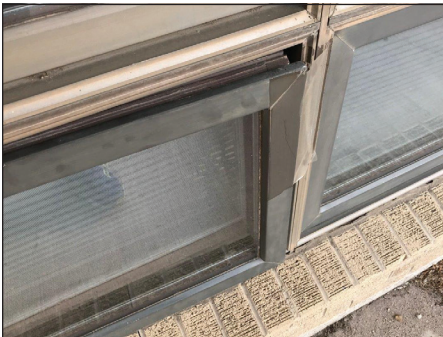
DAMAGED WINDOW

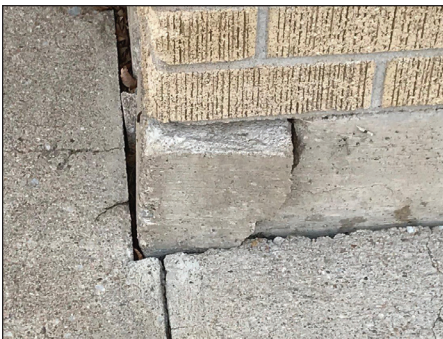
CRACKED FOUNDATION

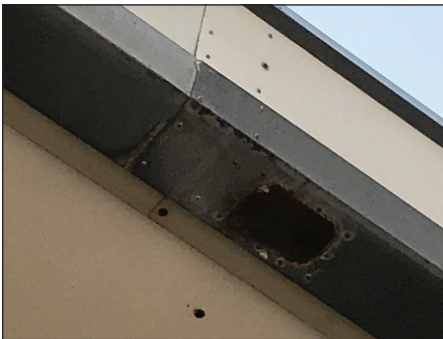
MISSING DOWNSPOUT

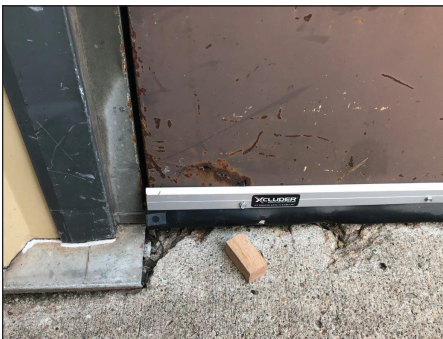
RUSTED DOOR AND FRAME

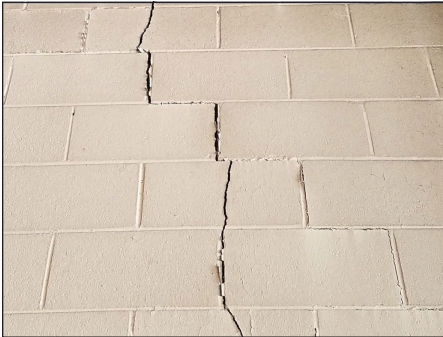
CRACKED CMU

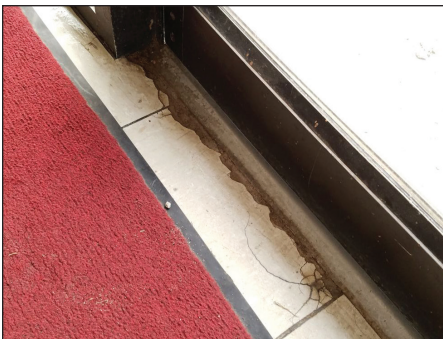
DAMAGED TILE

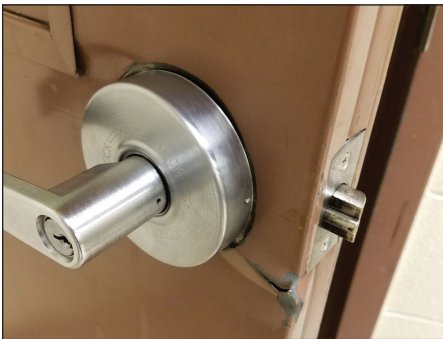
DAMAGED DOOR AND PANELS

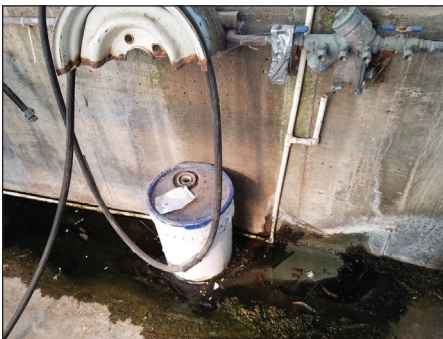
STAGNANT WATER

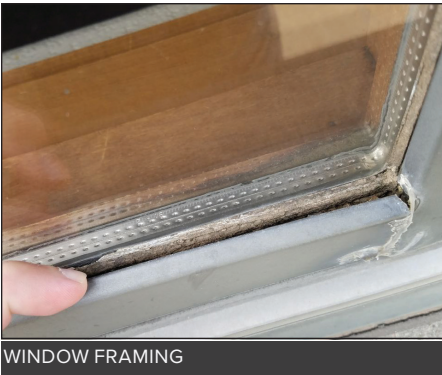
WINDOW FRAMING

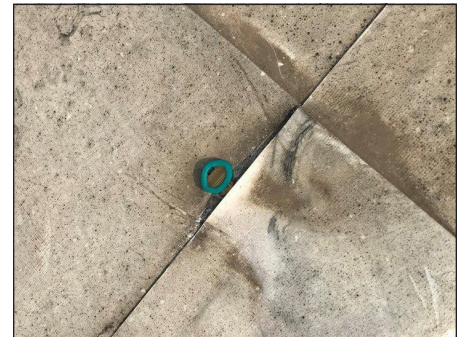
LOOSE ROOF MEMBRANE

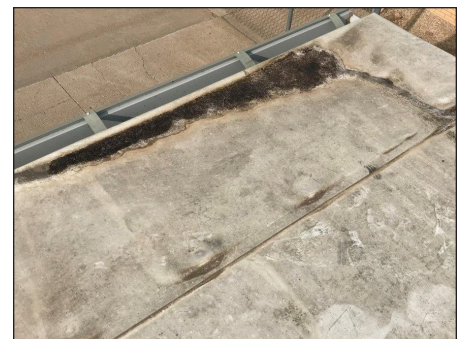
PONDING WATER

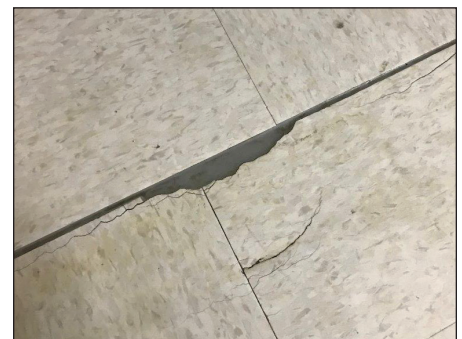
CRACKED TILE
