Rawlins County USD 105 Facility Assessment

Elementary School Assessment

Junior/Senior High School Assessment

Agriculture and Maintenance Shop Assessment

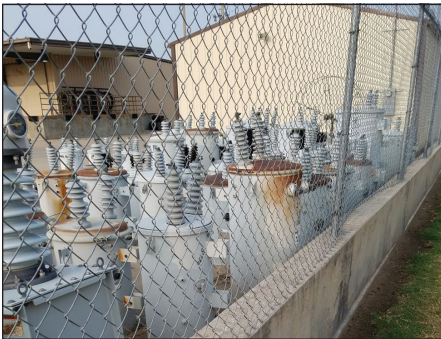
HIGH-VOLTAGE EQUIPMENT

1. Some areas of perimeter fencing need replaced.
2. Additional fencing recommended for securing playground area.
3. High-voltage equipment within arm's reach along fencing.

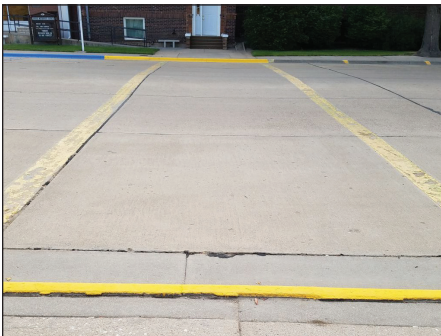
NO ADA CURB CUTS

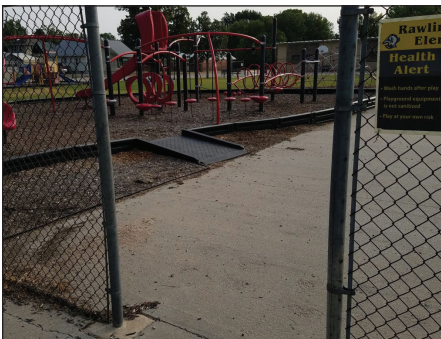
SECURE PLAYGROUND

4. High-voltage equipment, gas meter, and air conditioning units all exposed in playground area.
5. Sidewalks have cracks in areas.
6. North sidewalks have multiple cracks and areas of erosion.

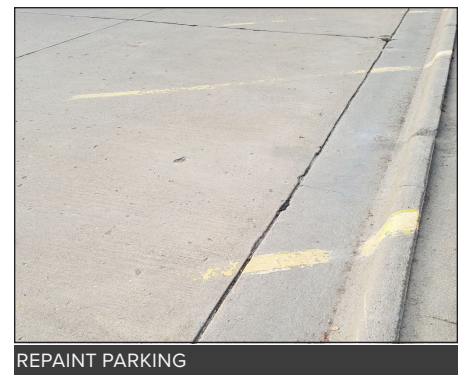
7. Parking striping is faded, chipping, and needs repainted.
8. Heavy curb erosion on north side needs repaired.
9. Additional building signage recommend being more visible.

REPAINT PARKING

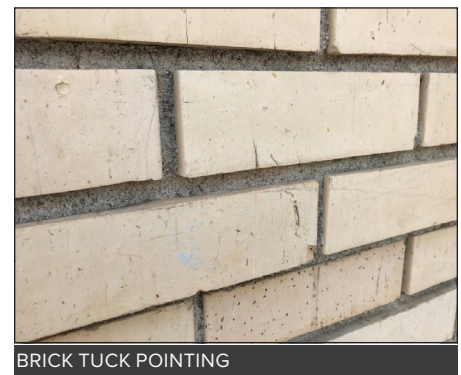
1. Brick tuck point is needed.
2. There are minor cracks at brick face.
3. Sealants need replaced.
4. Joints at gutters and downspouts are leaking and rusting.
5. Downspouts are rusted.
6. Metal fascia panels are coming loose.
7. Flashing needs replaced at canopy.
8. Structural steel is rusting at canopy.
9. Soffit panels are coming loose at canopy.
10. Soffit panels are rusting behind gutters.
11. Window gaskets and sealants are deteriorating.
12. Windows at cafeteria need replaced (moisture is migrating inside windowpanes and glazing sealant is deteriorating).
13. Teachers informed us that windows need replaced.
14. Sealant is needed around louvers.
15. Exterior doors are under 3 feet wide and non-ADA-compliant.
16. Door hinges are rusting.

BRICK TUCK POINTING

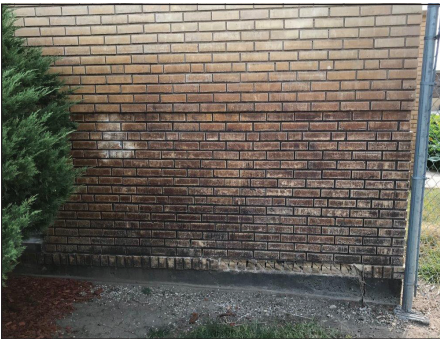
BRICK CLEANING

1. Brick is stained and needs cleaned.
2. Brick tuck pointing is needed.
3. Areas of brick are spalling.
4. Cracked bricks at building corners.
5. Cracking at building joint by gym.
6. Sealants need replaced.
7. Sealants are needed at mechanical penetrations.
8. Downspouts are damaged.
9. Splashblocks are needed.
10. Gutter joints are rusting.
11. Fascia panels are rusting.
12. Soffits are cracking at older building addition.
13. Metal soffit panels have multiple holes and loose fasteners.
14. Structural steel at entry canopy is rusting.
15. Multiple glass blocks are damaged and need replaced.
16. Windows at gym are damaged and need replaced.
17. Teachers informed us that windows need replaced.
18. Doors are under 3 feet wide and not ADA accessible.
19. Doors at gym are at end of life and need replaced.

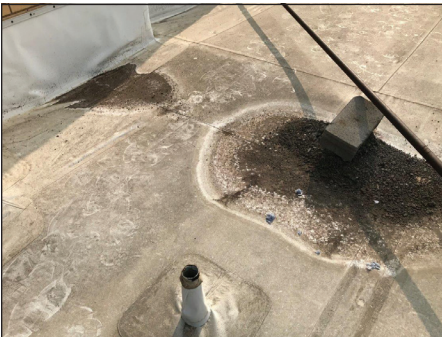
PONDING WATER

7. Mechanical exhaust vents are rusting and have hail damage.
8. Soffits are loose, and need secured.
9. Multiple water leaks observed on the interior.
10. Evidence of ponding water.

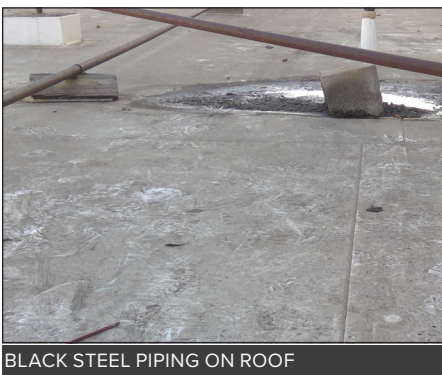
BLACK STEEL PIPING ON ROOF

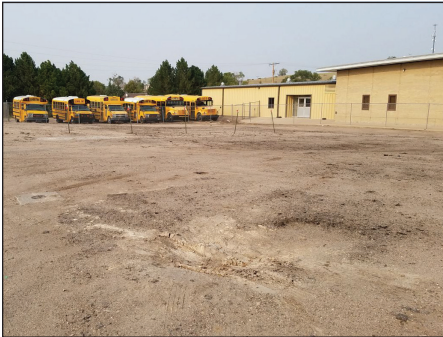
STUDENT PARKING

1. Cracked sidewalks and settlement in multiple areas.
2. Asphalt parking has erosion occurring.
3. Student parking is gravel with multiple holes, and washout in northeast corner.

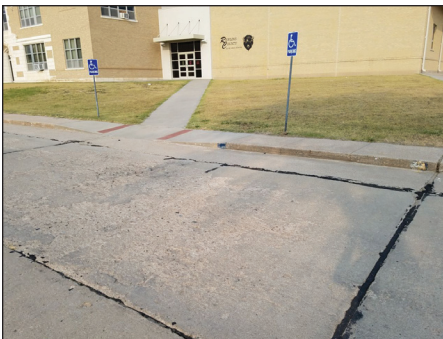
PARKING STALLS

4. Parking lot and on-street parking need repainted.
5. Areas of concrete curbing are damaged.
6. Paths to arrive on-site are not ADA accessible.
7. Bus and parent loading/unloading may be located along same street, causing traffic congestion.

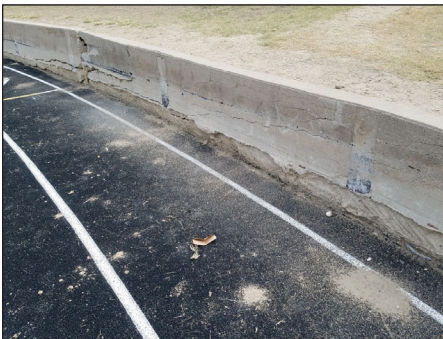
RETAINING WALL

11. Recommend moving handicap stall to have closest possible path of travel to building entry.
12. Stairs missing outer handrails.
13. Retaining walls failing along athletic track.

14. Retaining wall at school entry has minor cracks.
15. Field has excessive crown for water drainage.
16. Scoreboard is weathered with some minor dents.

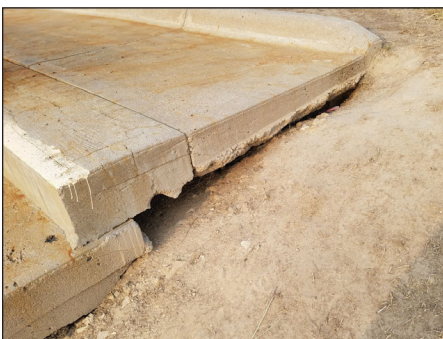
SOIL EROSION

8. Elevation changes throughout site create multiple areas where erosion is occurring.
9. Some low spots observed near building foundation.
10. Handicap parking stalls need signage.

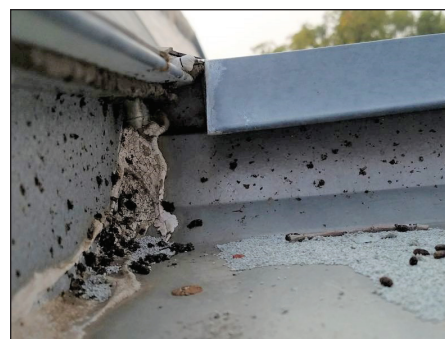
ROOF OPENINGS

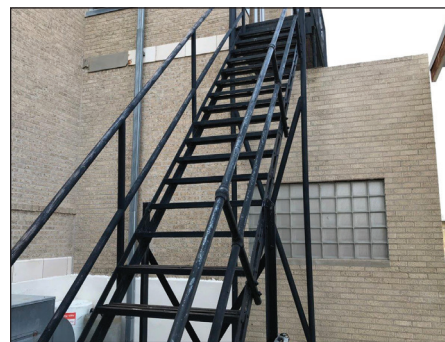
1. Stairs to/from cafeteria do not meet code requirements.
2. Recommend reworking egress stairs to provide ADA-accessible exit.
3. Recommend providing enclosed egress stairs for second story exits.
4. Handrails and guardrails are not to code.
5. Boiler room ramp is not to code.
6. Elevator does not meet current code requirements. Recommend new elevator with stair tower.
7. Attic access above stage is not safe with unsecured ladder.
8. Recommend providing cafeteria and kitchen at first floor.
9. Office needs to be separate from kitchen space.
10. Informed by staff of possible bat infestation above gymnasium. Recommend further investigation of pest removal process.

NON-COMPLIANT EGRESS STAIR

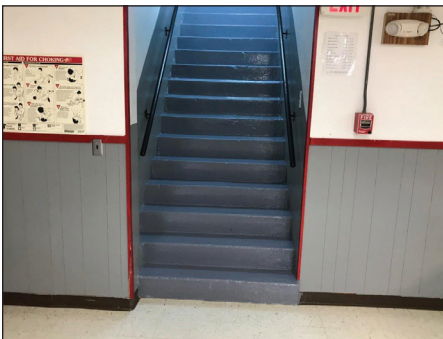
NON-ADA EGRESS

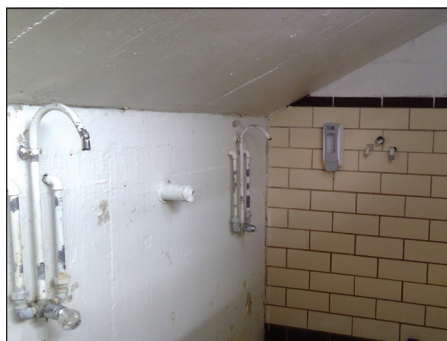
9. **Showers:** Small Locker Room: exposed piping; knob-handle showers in locker rooms; Football Locker: tiled gang shower with single-handle showers
10. **Wall Hydrants:** Hose bibb with knob, likely not freezeproof; Music Addition: newer loose key style

SMALL LOCKER ROOM SHOWERS

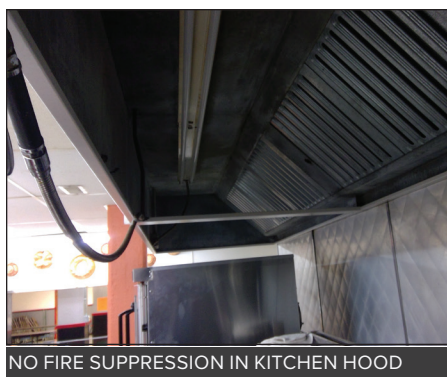
NO FIRE SUPPRESSION IN KITCHEN HOOD

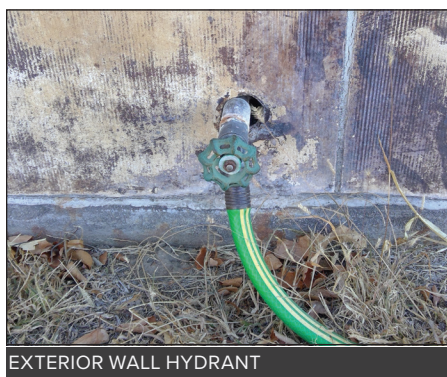
EXTERIOR WALL HYDRANT

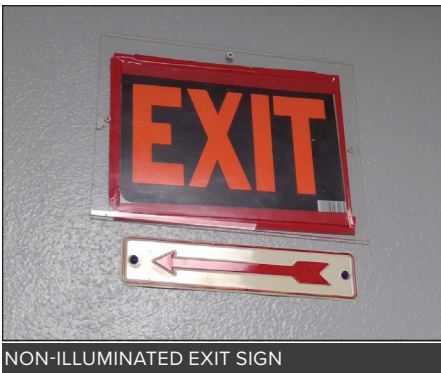
NON-ILLUMINATED EXIT SIGN

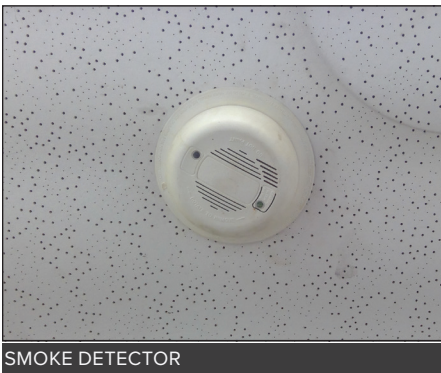
SMOKE DETECTOR

1. **Smoke and Heat Detectors:** Ceiling smoke detectors in some locations; recommend investigating need for full coverage

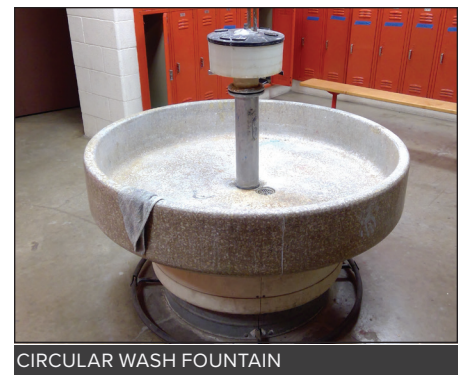
CIRCULAR WASH FOUNTAIN

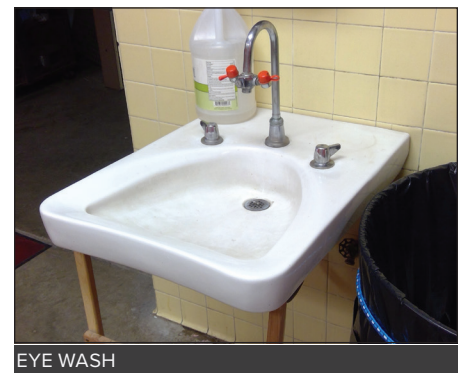
1. **Drinking Fountains/Water Coolers:** None
2. **Water Heaters:** Bradford White 40-gallon gas-fired unit (1999) may be approaching end of life
3. **Circulation Pumps:** None
4. **Drainage and Vent Piping:** Cast-iron/PVC/galvanized
5. **Gas Piping:** Black steel
6. **Eyewash:** Eyewash attachment at two-handle lavatory; recommend dedicated eye wash station.

EYE WASH

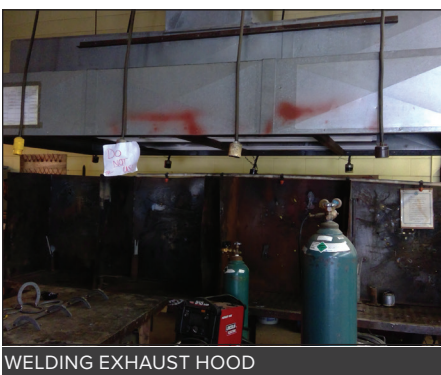
1. **Ventilation Air:** Via split system and shop ventilation fans
2. **Air Distribution Devices:** Round ceiling diffusers; linear bar floor diffusers
3. **HVAC System:** Split System: (2013) Payne; horizontal above classroom, age and type unknown; Greenhouse: Evaporative cooler
4. **Controls:** Honeywell programmable thermostat
5. **Unit Heaters:** Shop/Wash Bay: Reznor gas-fired forced air heaters (likely original '79, may need replaced soon); Greenhouse: Modine gas-fired forced air heaters (likely original '79, may need replaced soon)
6. **Shop Exhaust:** Welding exhaust hood; recommend verifying operation and servicing fan if required

WELDING EXHAUST HOOD

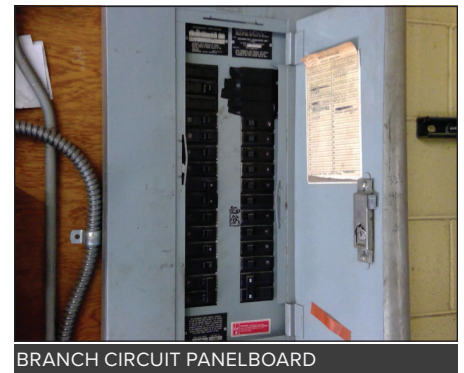
1. **Branch Circuit Panelboards:** Westinghouse panel; recommend replacing
2. **Load Centers:** Cutler Hammer panel; recommend replacing
3. **Enclosed Disconnect Switches:** Heavy-duty type disconnects for equipment; recommend replacing old units to ensure proper function
4. **Feeders (Exposed to View):** Installed in EMT type conduit raceways, MC cable, and wiremold to devices
5. **Ambient Lighting (Class, Halls, Offices, etc.):** Surface incandescent; Recessed, and surface-mounted T8 fluorescent luminaires, fluorescent strips
6. **Emergency Lighting (Condition & Code):** Recommend additional emergency lighting solutions
7. **Exterior Building-Mounted Lighting:** HID wall packs
8. **Shop Lighting:** Fluorescent strips

BRANCH CIRCUIT PANELBOARD

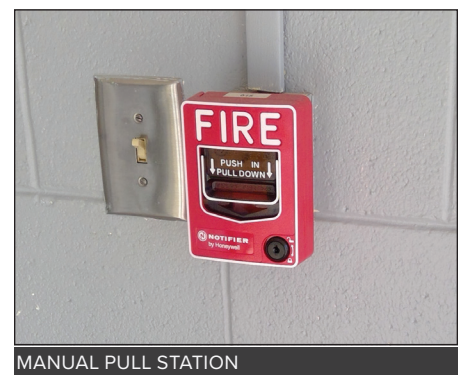
MANUAL PULL STATION

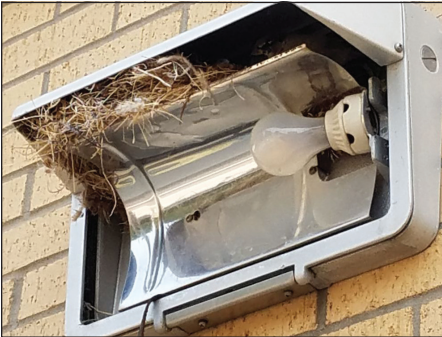
MISSING LIGHT COVER

1. Exterior lighting is missing the cover and birds are nesting.
2. Control joint sealant needs replaced.
3. Exterior door panel is beginning to fade.
4. Exterior door hinges are rusting.

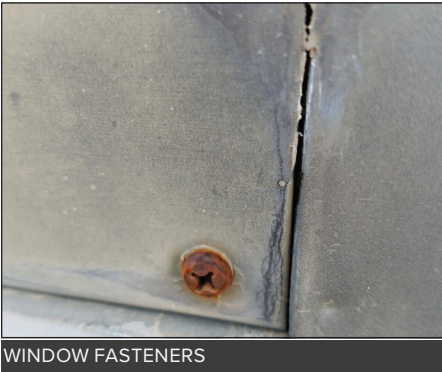
WINDOW FASTENERS

1. Exterior sealants need replaced.
2. Section of gutter is missing and causing staining on brick.
3. Metal fascia is rusting behind gutters.
4. Soffit lighting has missing lightbulb.
5. Finish paint is peeling on soffit.
6. Windows are looking to be close to end of life expectancy.
7. Windows are weathered.
8. Gaskets and seals are deteriorating.
9. Main entry door panel and hardware are weathered.

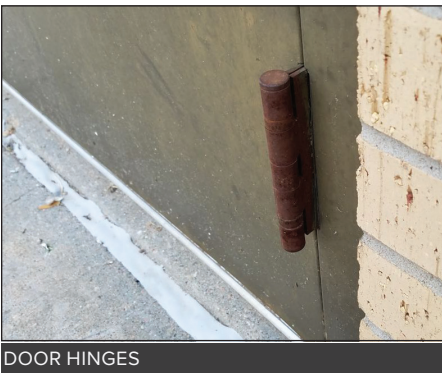
DOOR HINGES

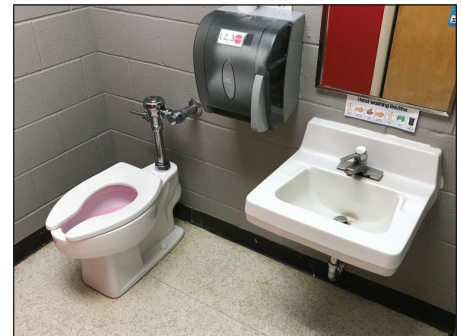
NON-ADA-COMPLIANT RESTROOM

1. Code analysis recommended to determine if area separation requirements are met.
2. No high/low drinking fountains. Recommend bottle filling station.
